XPR ANTIQUE

Extreme polymer rigid core waterproof

DATA SHEET ANTIQUE

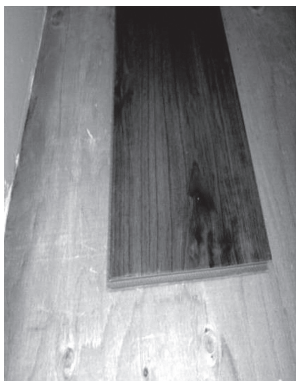
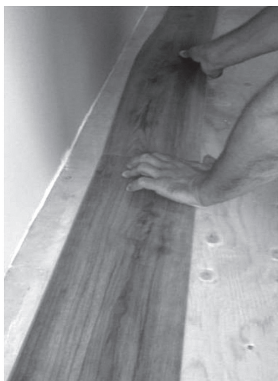
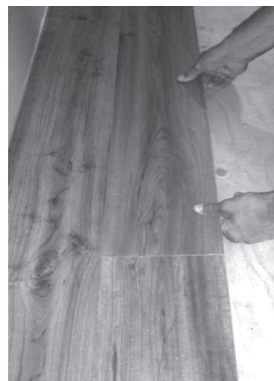
1. Diagram #1: Start with the first plank in the left corner of the room, tongue-side facing out from the wall to the length and to the right on the width. Work from left to right.
2. Diagram #2: Position the following planks as an exact extension of the first one.
3. Cut to fit the last plank of the row. To do this you can use a utility knife to score the surface at the appropriate point and then break the tile over an edge. A laminate cutter or miter saw can be used as well.

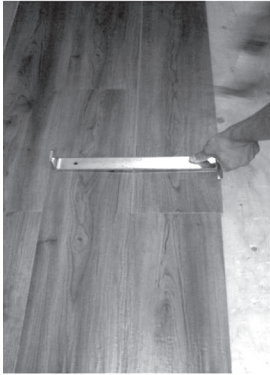
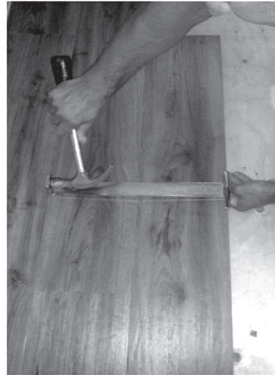
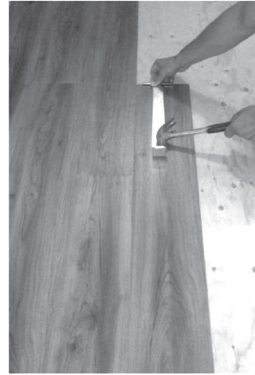
1. Diagram #3: Begin the second row with the cut-off end to start the next and subsequent rows. Allow at least an 8" stagger for the end seams. For positioning the planks together, starting with the first tile in the row, raise the plank at a 45-degree angle, insert the lengthways tongue into the lengthways groove and lower the plank while holding the two together until they are flat and tightly together. Close the joint using hand pressure, tapping block or pull bar.
2. Diagram #4: Lever the next sheet in place from the front side so that only a very short distance remains for it to be pushed into the lengthways connection.

- Diagram #5, 6 and 7: Raise the plank slightly and push it into the lengthways tongue, first close to the front connection, then the rest. Make sure seams are tight on ends and sides using pull bar or tapping block before proceeding. Continue the installation to the last row of sheets, as described.
- How to shorten doorframes: Position a loose plank face down, close to the doorframe, and cut with a jamb saw.
- People can walk on the flooring immediately after the installation. Remove the wedges. Nail or screw moldings to the wall, never to the floor.
