XPR STANDARDS

Extreme polymer rigid core waterproof

XPR + PAD

DATA SHEET STANDARDS

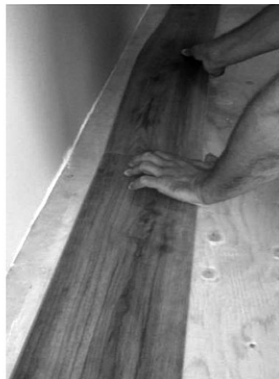
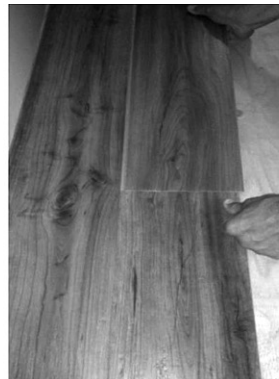
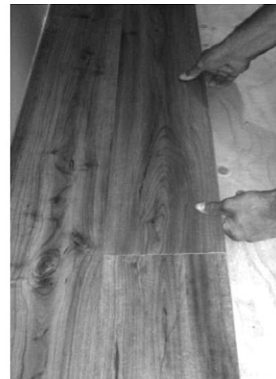
1. Diagram #1: Start with the first plank in the left corner of the room, tongue-side facing out from the wall to the length and to the right on the width. Work from left to right.
2. Diagram #2: Position the following planks as an exact extension of the first one.
3. Cut to fit the last plank of the row. To do this you can use a utility knife to score the surface at the appropriate point and then break the tile over an edge. A laminate cutter or miter saw can be used as well.

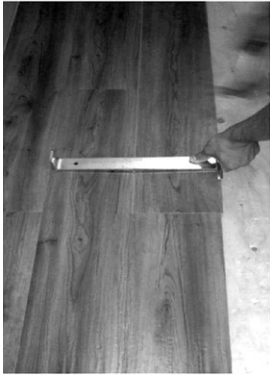
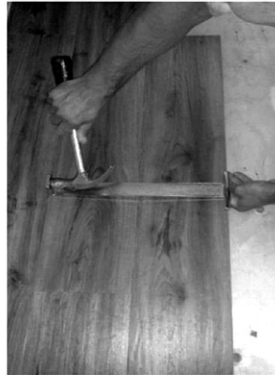
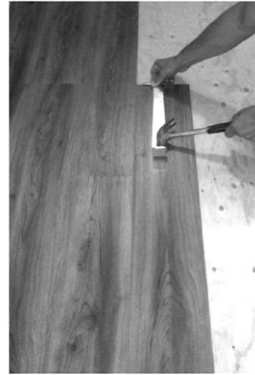
1. Diagram #3: Begin the second row with the cut-off end to start the next and subsequent rows. Allow at least an 8" stagger for the end seams. For positioning the planks together, starting with the first tile in the row, raise the plank at a 45-degree angle, insert the lengthways tongue into the lengthways groove and lower the plank while holding the two together until they are flat and tightly together. Close the joint using hand pressure, tapping block or pull bar.
2. Diagram #4: Lever the next sheet in place from the front side so that only a very short distance remains for it to be pushed into the lengthways connection.

3. Diagram #5, 6 and 7: Raise the plank slightly and push it into the lengthways tongue, first close to the front connection, then the rest. Make sure seams are tight on ends and sides using pull bar or tapping block before proceeding. Continue the installation to the last row of sheets, as described.

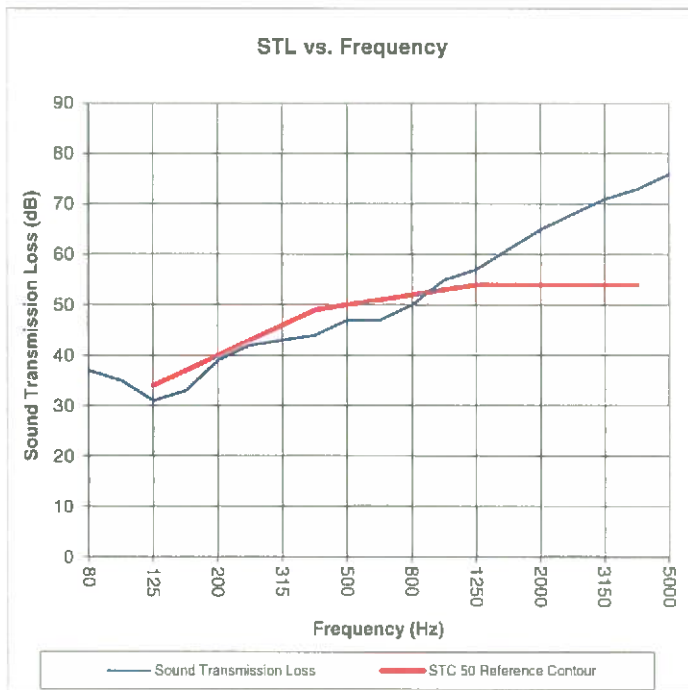
* Due to high insulating value of specimen, background levels limit results at these frequencies.

STL = Sound Transmission Loss, dB
 Δ STL = Uncertainty for 95% Confidence Level

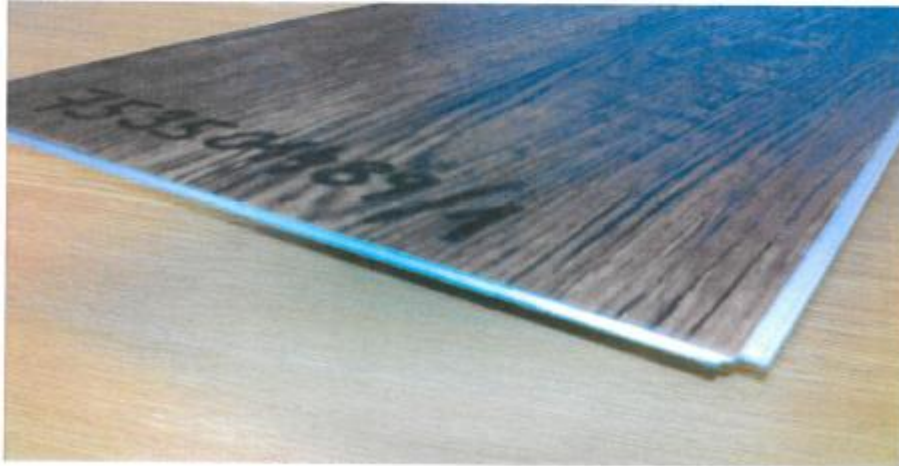
Sample photo:

- Wear layer: 0.5 mm (PVC)
- Base layer: 3.85 mm (PVC)
- Balance layer: 0.65 mm (PVC)

Total thickness (wear layer thickness): 5.0 mm (0.5 mm)

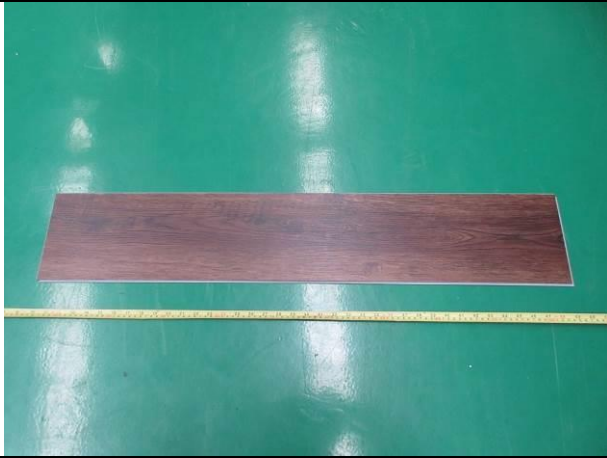
| <p>C.1 Surface view of sample</p> | <p>C.2 Back view of sample</p> |

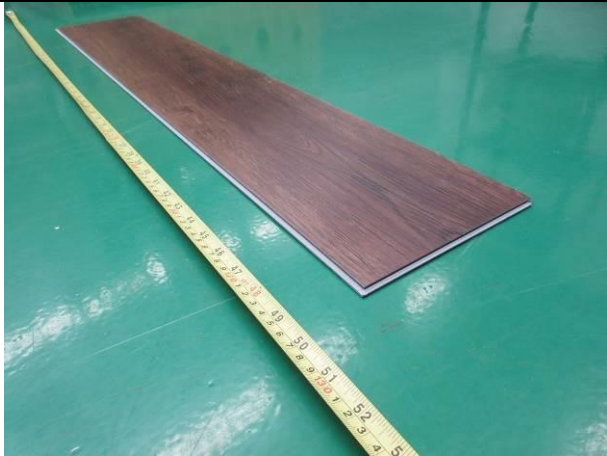
| A photograph showing a cross-section of the sample. The top layer has a wood-grain pattern, and the bottom layer is a lighter, solid color. A yellow measuring tape is placed diagonally below the sample for scale. | <p>Blank</p> |
| <p>C.3 Section view of sample</p> | |
