# XPR WEATHERED

Extreme polymer rigid core waterproof

XPR + PAD

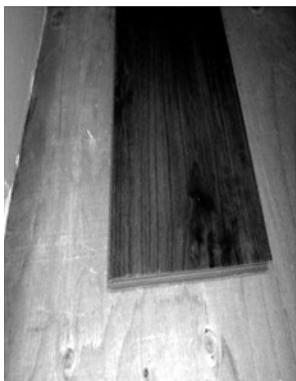
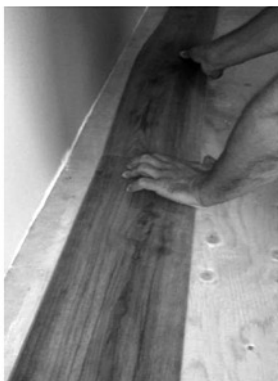
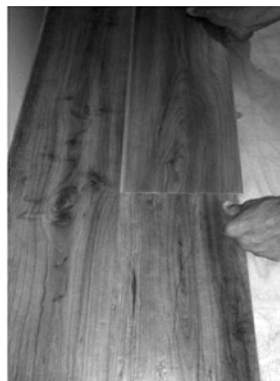
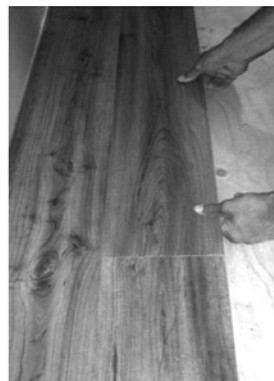
1. Diagram #1: Start with the first plank in the left corner of the room, tongue-side facing out from the wall to the length and to the right on the width. Work from left to right.
2. Diagram #2: Position the following planks as an exact extension of the first one.
3. Cut to fit the last plank of the row. To do this you can use a utility knife to score the surface at the appropriate point and then break the tile over an edge. A laminate cutter or miter saw can be used as well.

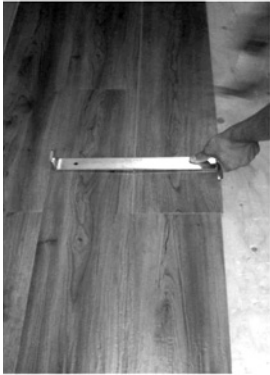
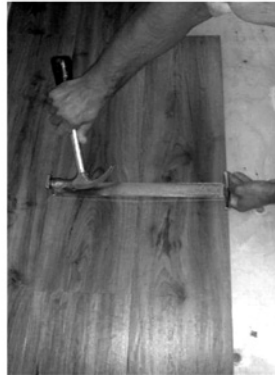
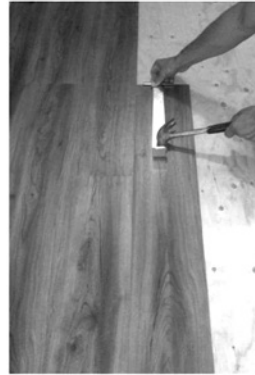
1. Diagram #3: Begin the second row with the cut-off end to start the next and subsequent rows. Allow at least an 8" stagger for the end seams. For positioning the planks together, starting with the first tile in the row, raise the plank at a 45-degree angle, insert the lengthways tongue into the lengthways groove and lower the plank while holding the two together until they are flat and tightly together. Close the joint using hand pressure, tapping block or pull bar.
2. Diagram #4: Lever the next sheet in place from the front side so that only a very short distance remains for it to be pushed into the lengthways connection.

3. Diagram #5, 6 and 7: Raise the plank slightly and push it into the lengthways tongue, first close to the front connection, then the rest. Make sure seams are tight on ends and sides using pull bar or tapping block before proceeding. Continue the installation to the last row of sheets, as described.

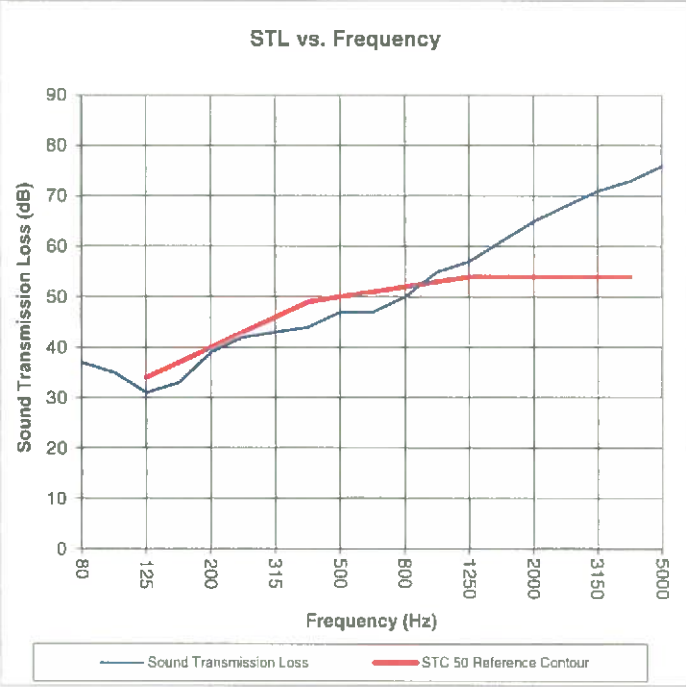
Sound Transmission Loss Test Data			Page 5 of 5																																																												
Test: ASTM E 90 - 09 (2016) / ASTM E 413 - 16																																																															
Test Report: NGC 5019077																																																															
Test Date: 9/25/2019																																																															
Specimen Size [m <sup>2</sup> ]: 17.8																																																															
<b>Sound Transmission Class STC = 50 dB</b>

<table><tr> <th>Frequency [Hz]</th> <th>STL [dB]</th> <th>ΔSTL</th> </tr></table>

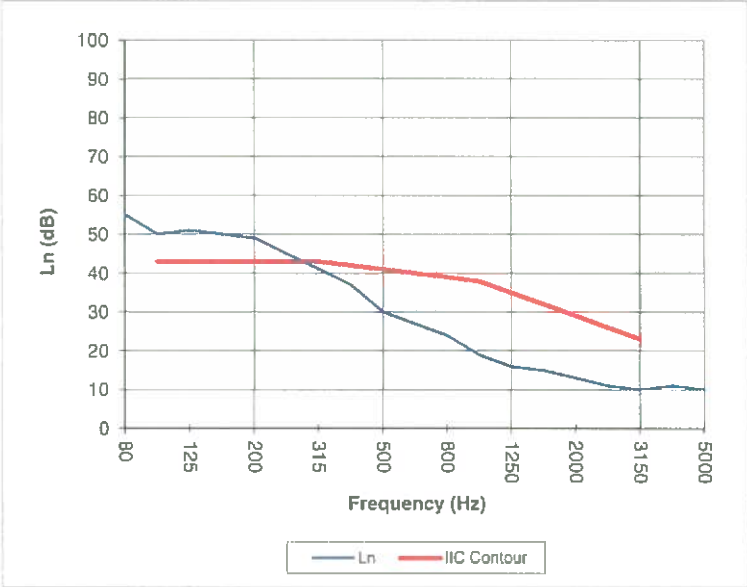
Frequency [Hz]	L <sub>n</sub> [dB]	80	55	100	50	125	51	160	50	200	49	250	45	315	41	400	37	500	30	630	27	800	24	1000	19	1250	16	1600	15	2000	13	2500	11	3150	10	4000	11	5000	10

Frequency [Hz]	L <sub>n</sub> [dB]																																								
80	55																																								
100	50																																								
125	51																																								
160	50																																								
200	49																																								
250	45																																								
315	41																																								
400	37																																								
500	30																																								
630	27																																								
800	24																																								
1000	19																																								
1250	16																																								
1600	15																																								
2000	13																																								
2500	11																																								
3150	10																																								
4000	11																																								
5000	10																																								
<p>* Due to high insulating value of specimen, background levels limit results at these frequencies.</p> <p style="text-align: center;">L<sub>n</sub> = Normalized Sound Pressure Level, dB</p>

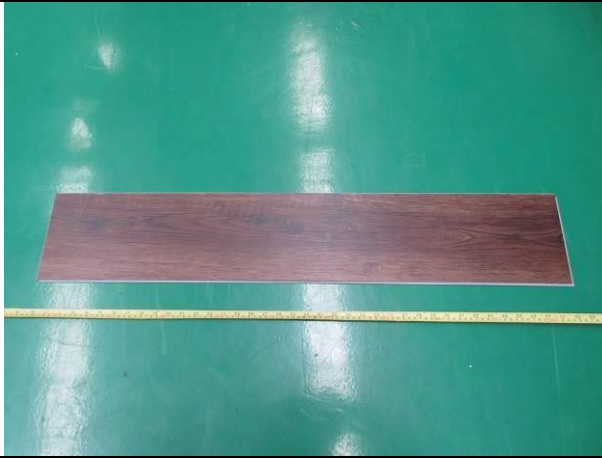
A photograph showing the top surface of a rectangular sample with a dark brown wood-grain pattern. A yellow measuring tape is placed horizontally below the sample for scale.

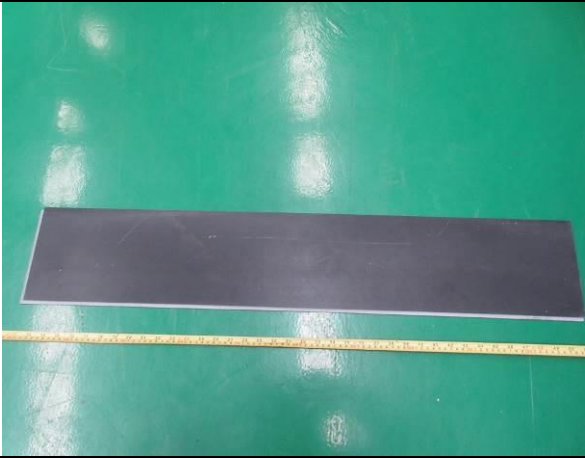
A photograph showing the back of the rectangular sample, which is a solid dark grey or black color. A yellow measuring tape is placed horizontally below the sample for scale.
<p>C.1 Surface view of sample</p>	<p>C.2 Back view of sample</p>

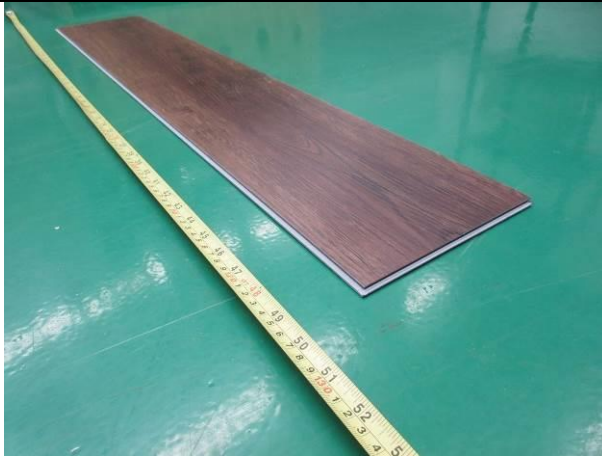
A photograph showing a diagonal section of the sample, revealing its thickness and the layered structure of the wood-grain top layer and the dark back layer. A yellow measuring tape is placed diagonally below the sample for scale.	<p>Blank</p>
<p>C.3 Section view of sample</p>
