XPR ARCHITECT

Extreme polymer rigid core waterproof

XPR + PAD

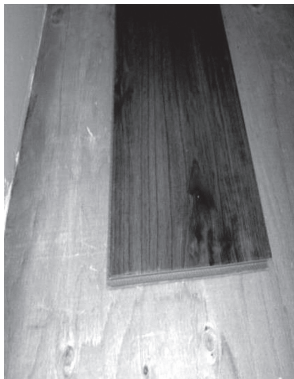
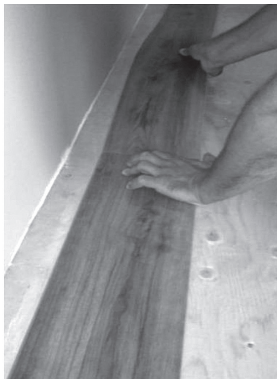
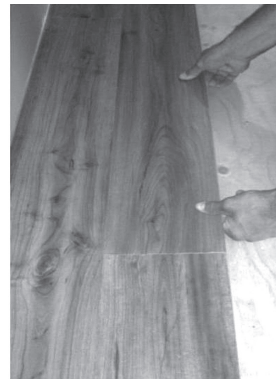
1. Diagram #1: Start with the first plank in the left corner of the room, tongue-side facing out from the wall to the length and to the right on the width. Work from left to right.
2. Diagram #2: Position the following planks as an exact extension of the first one.
3. Cut to fit the last plank of the row. To do this you can use a utility knife to score the surface at the appropriate point and then break the tile over an edge. A laminate cutter or miter saw can be used as well.

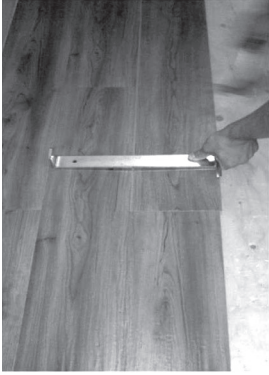
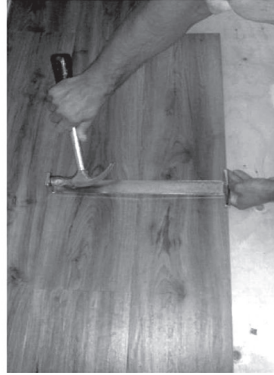
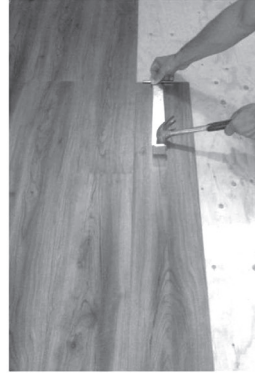
1. Diagram #3: Begin the second row with the cut-off end to start the next and subsequent rows. Allow at least an 8" stagger for the end seams. For positioning the planks together, starting with the first tile in the row, raise the plank at a 45-degree angle, insert the lengthways tongue into the lengthways groove and lower the plank while holding the two together until they are flat and tightly together. Close the joint using hand pressure, tapping block or pull bar.
2. Diagram #4: Lever the next sheet in place from the front side so that only a very short distance remains for it to be pushed into the lengthways connection.

3. Diagram #5, 6 and 7: Raise the plank slightly and push it into the lengthways tongue, first close to the front connection, then the rest. Make sure seams are tight on ends and sides using pull bar or tapping block before proceeding. Continue the installation to the last row of sheets, as described.
4. How to shorten doorframes: Position a loose plank face down, close to the doorframe, and cut with a jamb saw.
5. People can walk on the flooring immediately after the installation. Remove the wedges. Nail or screw moldings to the wall, never to the floor.

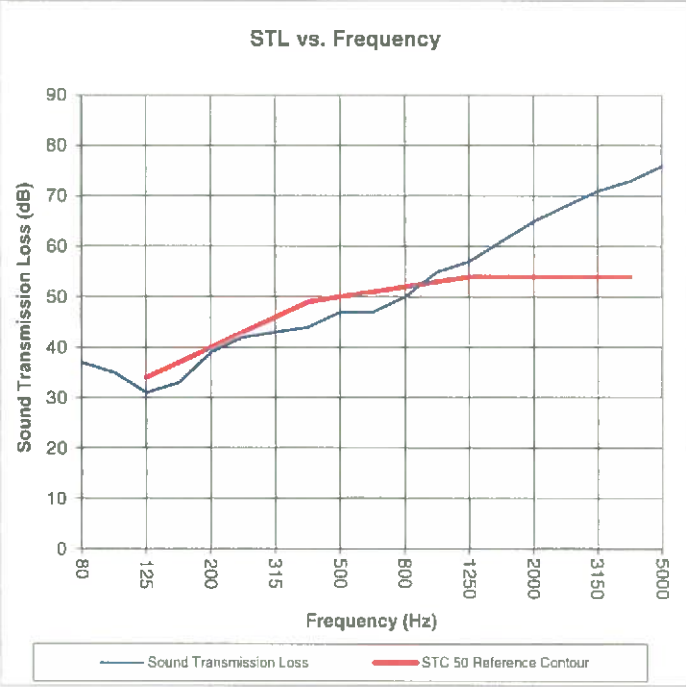
Sound Transmission Loss Test Data			Page 5 of 5																																																												
Test: ASTM E 90 - 09 (2016) / ASTM E 413 - 16																																																															
Test Report: NGC 5019077																																																															
Test Date: 9/25/2019																																																															
Specimen Size [m ²]: 17.8																																																															
Sound Transmission Class STC = 50 dB

<table><tr> <th>Frequency [Hz]</th> <th>STL [dB]</th> <th>ΔSTL</th> </tr></table>

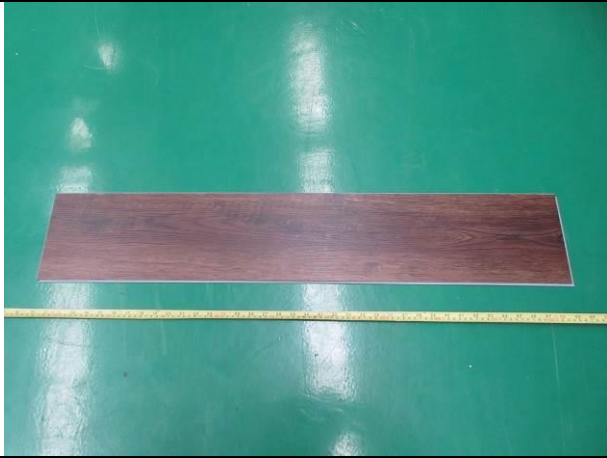
A photograph showing the top surface of a rectangular sample with a dark brown wood-grain pattern. A yellow measuring tape is placed horizontally below the sample for scale.

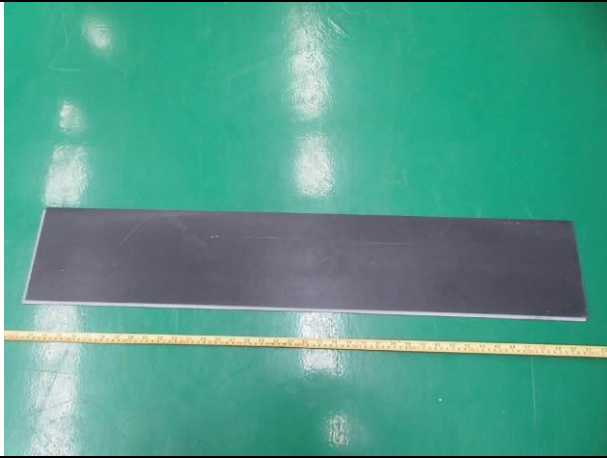
A photograph showing the back of the sample, which is a dark, solid color. A yellow measuring tape is placed horizontally below the sample for scale.
<p>C.1 Surface view of sample</p>	<p>C.2 Back view of sample</p>

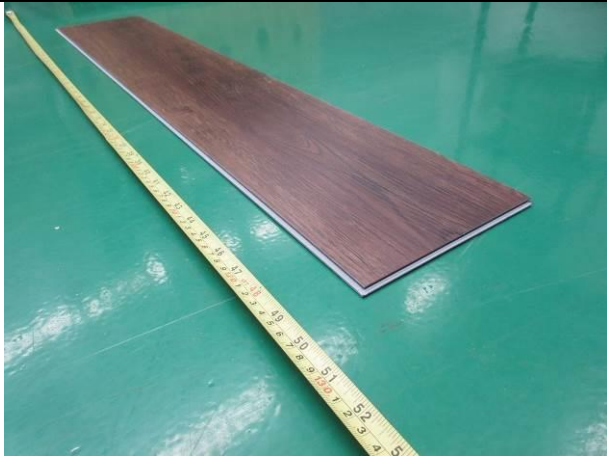
A photograph showing a cross-section of the sample. The top layer has a wood-grain pattern, and the bottom layer is a lighter, solid color. A yellow measuring tape is placed diagonally below the sample for scale.	<p>Blank</p>
<p>C.3 Section view of sample</p>
