# XPR STUDIO

Rigid core oversized plank

XPR + PAD

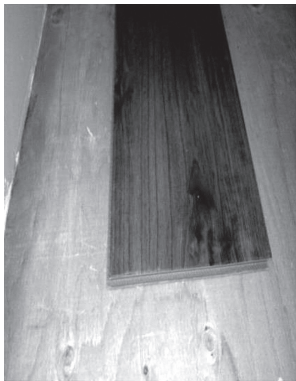
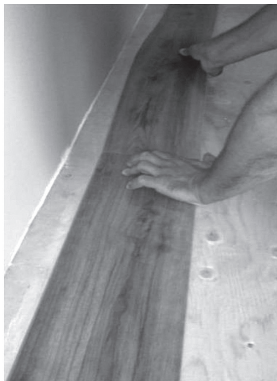
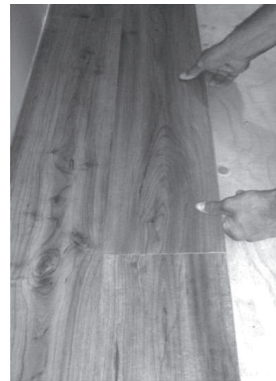
1. Diagram #1: Start with the first plank in the left corner of the room, tongue-side facing out from the wall to the length and to the right on the width. Work from left to right.
2. Diagram #2: Position the following planks as an exact extension of the first one.
3. Cut to fit the last plank of the row. To do this you can use a utility knife to score the surface at the appropriate point and then break the tile over an edge. A laminate cutter or miter saw can be used as well.

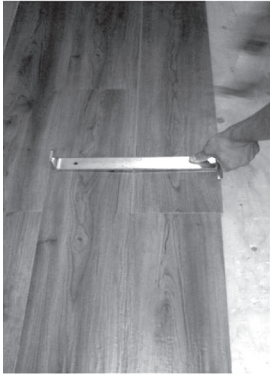
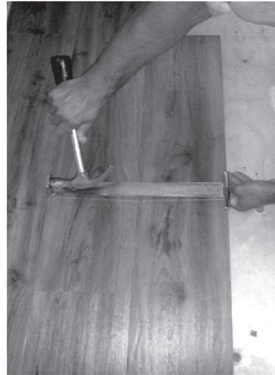
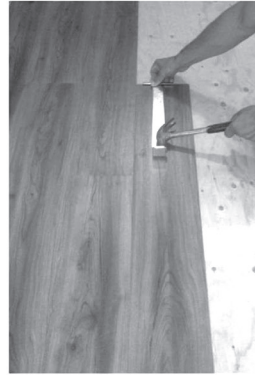
1. Diagram #3: Begin the second row with the cut-off end to start the next and subsequent rows. Allow at least an 8" stagger for the end seams. For positioning the planks together, starting with the first tile in the row, raise the plank at a 45-degree angle, insert the lengthways tongue into the lengthways groove and lower the plank while holding the two together until they are flat and tightly together. Close the joint using hand pressure, tapping block or pull bar.
2. Diagram #4: Lever the next sheet in place from the front side so that only a very short distance remains for it to be pushed into the lengthways connection.

3. Diagram #5, 6 and 7: Raise the plank slightly and push it into the lengthways tongue, first close to the front connection, then the rest. Make sure seams are tight on ends and sides using pull bar or tapping block before proceeding. Continue the installation to the last row of sheets, as described.

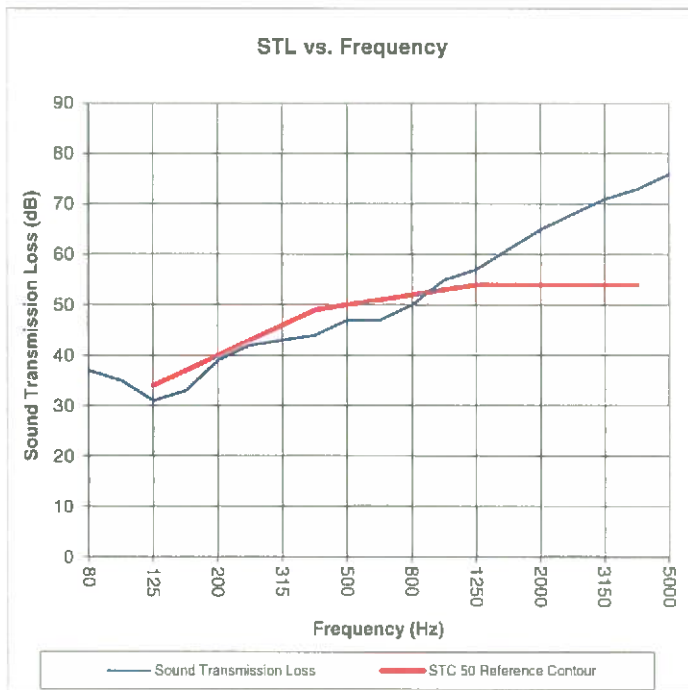
**Sound Transmission Class STC = 50 dB**

Frequency [Hz]	STL [dB]	ΔSTL
80	37	1.90
100	35	4.40
125	31	2.36
160	33	1.72
200	39	0.85
250	42	0.78
315	43	0.86
400	44	0.87
500	47	1.02
630	47	0.88
800	50	0.62
1000	55	0.37
1250	57	0.43
1600	61	0.77
2000	65	0.62
2500	68	1.17
3150	71	1.17
4000	73	1.61
5000	76	1.58

\* Due to high insulating value of specimen, background levels limit results at these frequencies.

STL = Sound Transmission Loss, dB  
 Δ STL = Uncertainty for 95% Confidence Level

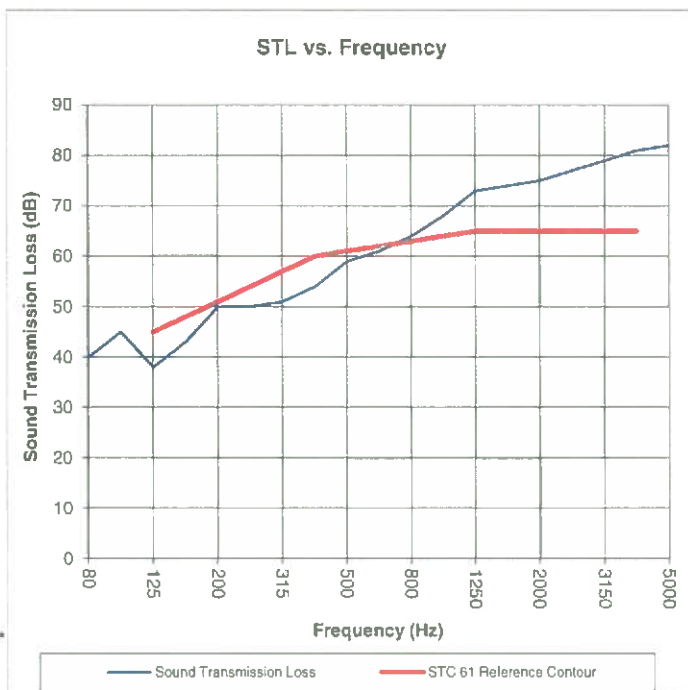
**Sound Transmission Class STC = 61 dB**

Frequency [Hz]	STL [dB]	ΔSTL
80	40	2.87
100	45	4.42
125	38	2.32
160	43	1.90
200	50	0.92
250	50	0.87
315	51	1.06
400	54	0.56
500	59	0.65
630	61	0.59
800	64	0.48
1000	68	0.35
1250	73	0.65
1600	74	0.46
2000	75	0.68
2500	77	0.89
3150	79	1.04
4000	81	1.47
5000	82	1.70

\* Due to high insulating value of specimen, background levels limit results at these frequencies.
